DROP TESTS OF SELECTED STEEL DRUMS

Prepared for
Transportation Development Centre
Transport Canada

by
InNOVAcorp
Environmental Simulation Lab

April 2003

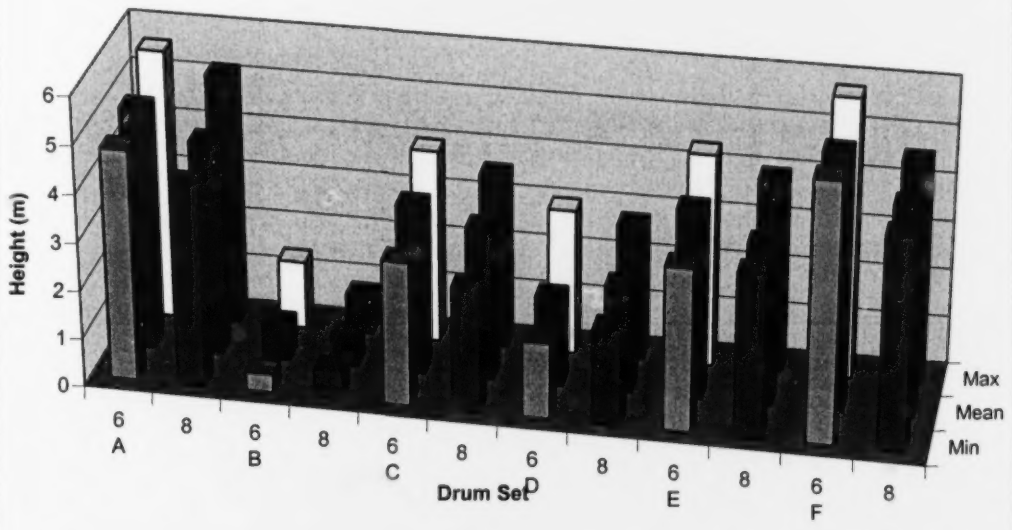
Figure. 3: Summary of Failure Heights

Table 2 summarizes the findings of the test program. Figure 1 shows these results graphically for comparison. In addition to the average failure heights, the minimum and maximum heights are shown to give a sense of the consistency of the data. More detailed results are given in Appendix B.

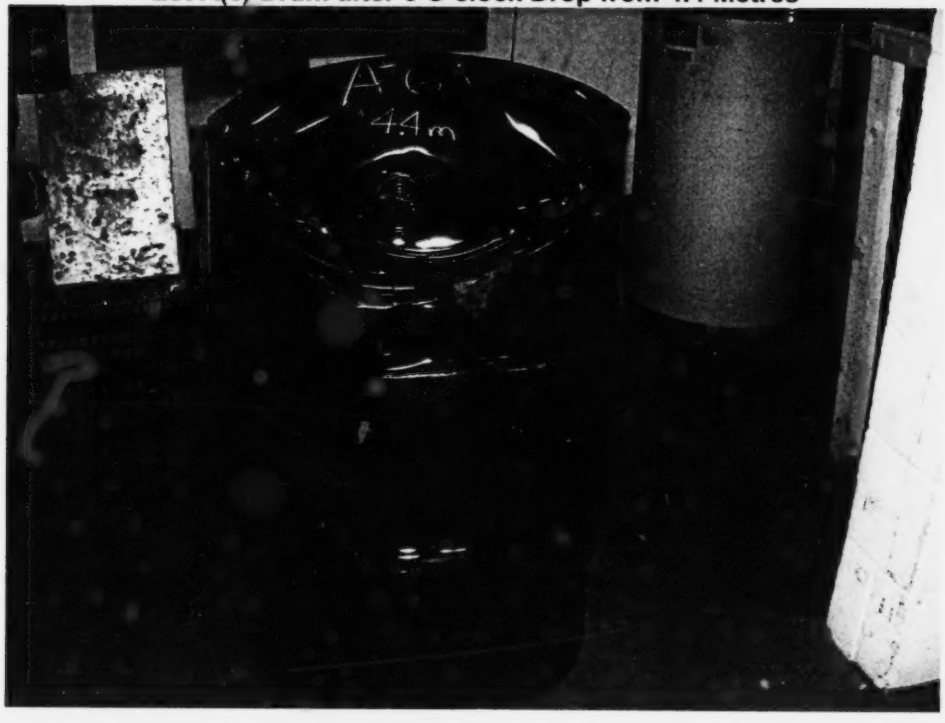
Photo 8
Lot A(6) Drum after 6 O'clock Drop from 4.4 Metres

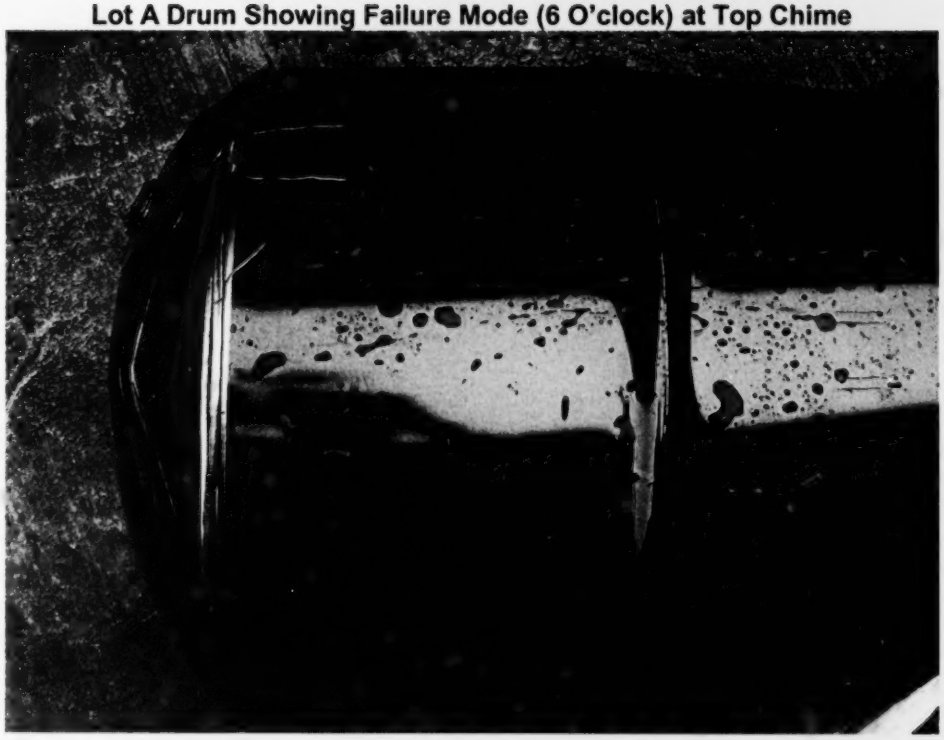
Photo 12
Lot A Drum Showing Failure Mode (6 O'clock) at Top Chime

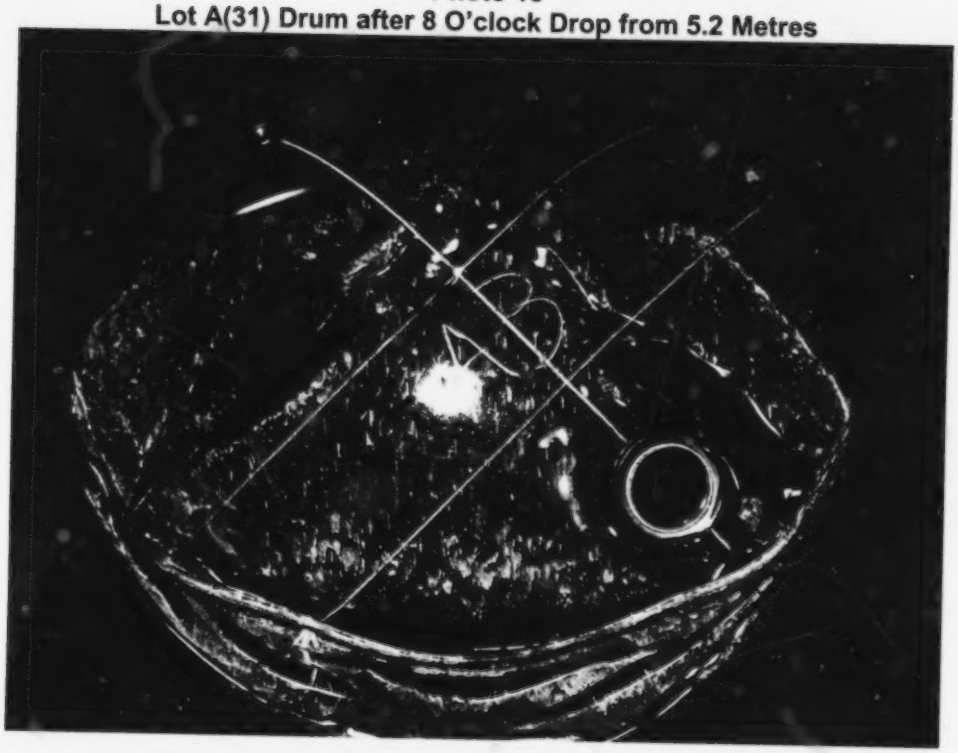
Photo 15
Lot A(31) Drum after 8 O'clock Drop from 5.2 Metres

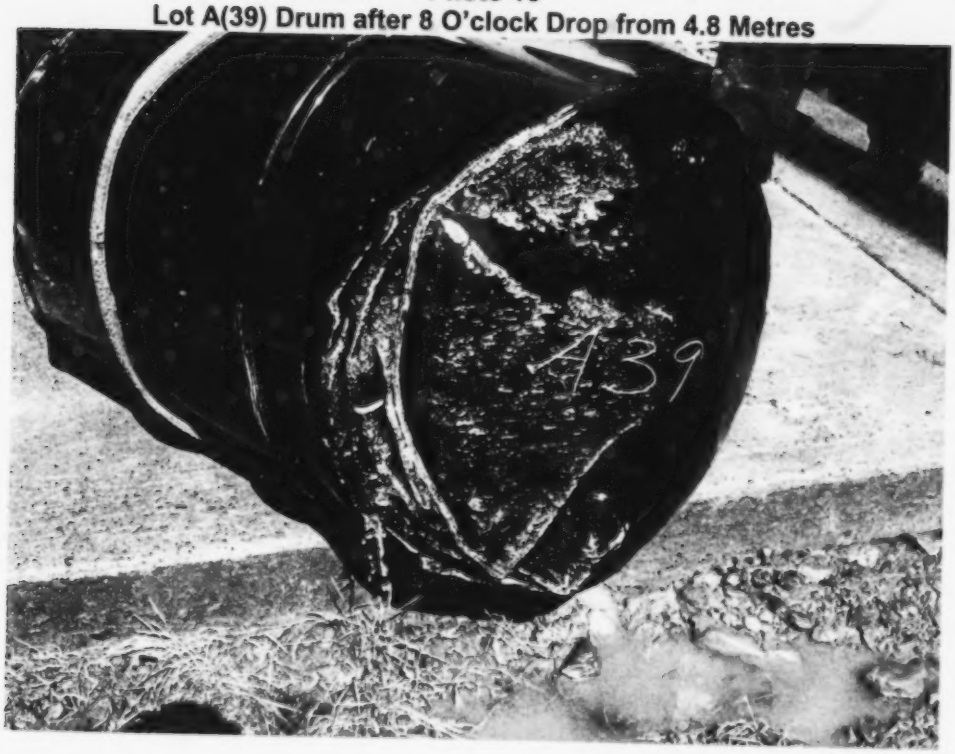
Photo 16
Lot A(39) Drum after 8 O'clock Drop from 4.8 Metres

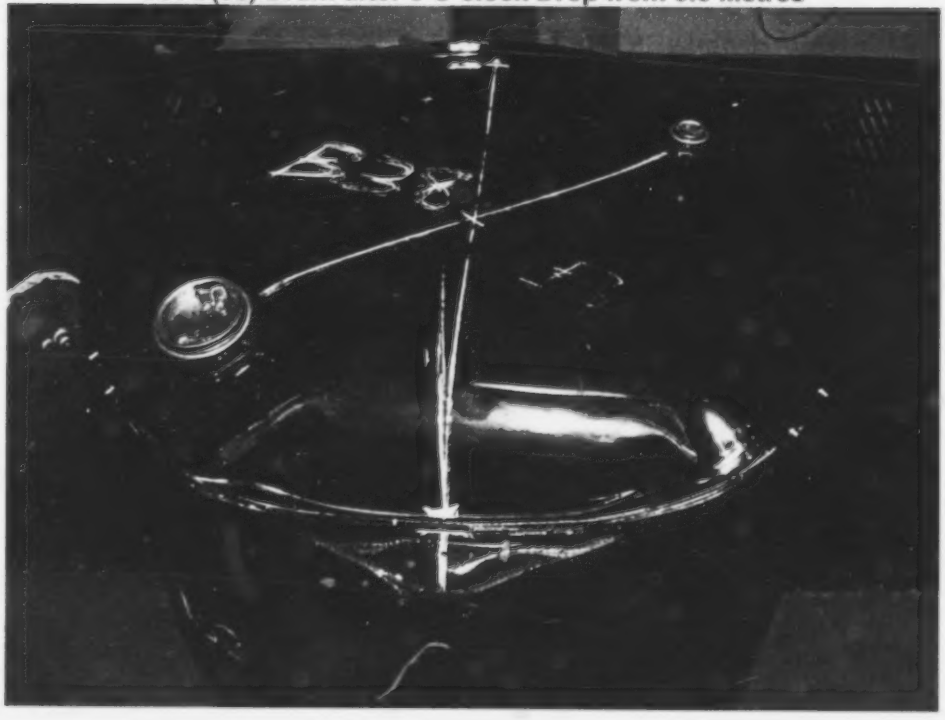
Photo 20
Lot B(38) Drum after 8 O'clock Drop from 0.6 Metres

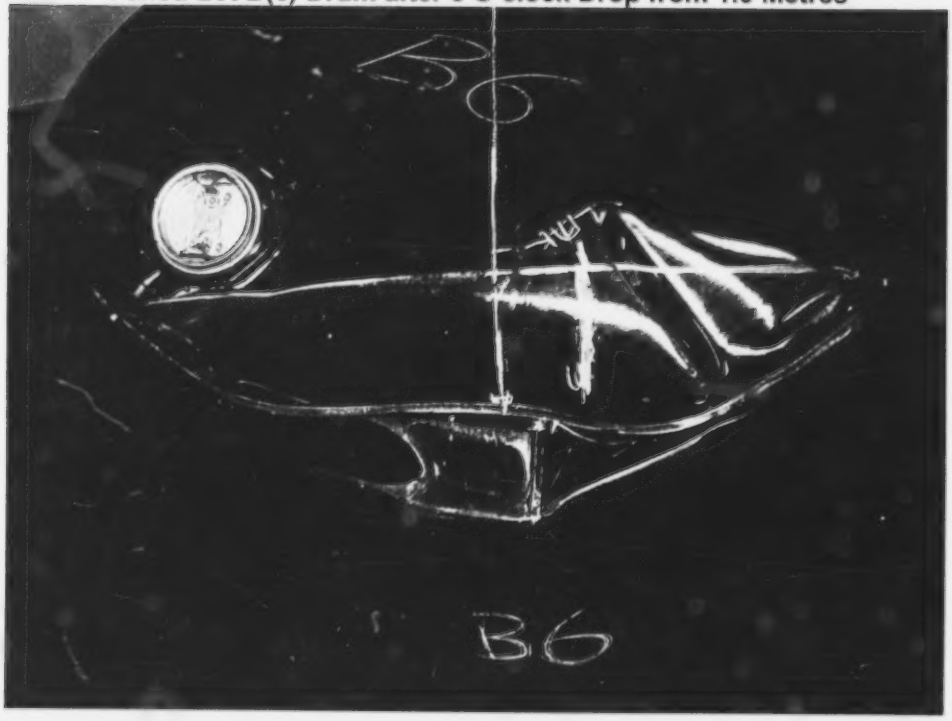
Photo 22
Failed Lot B(6) Drum after 8 O'clock Drop from 1.0 Metres

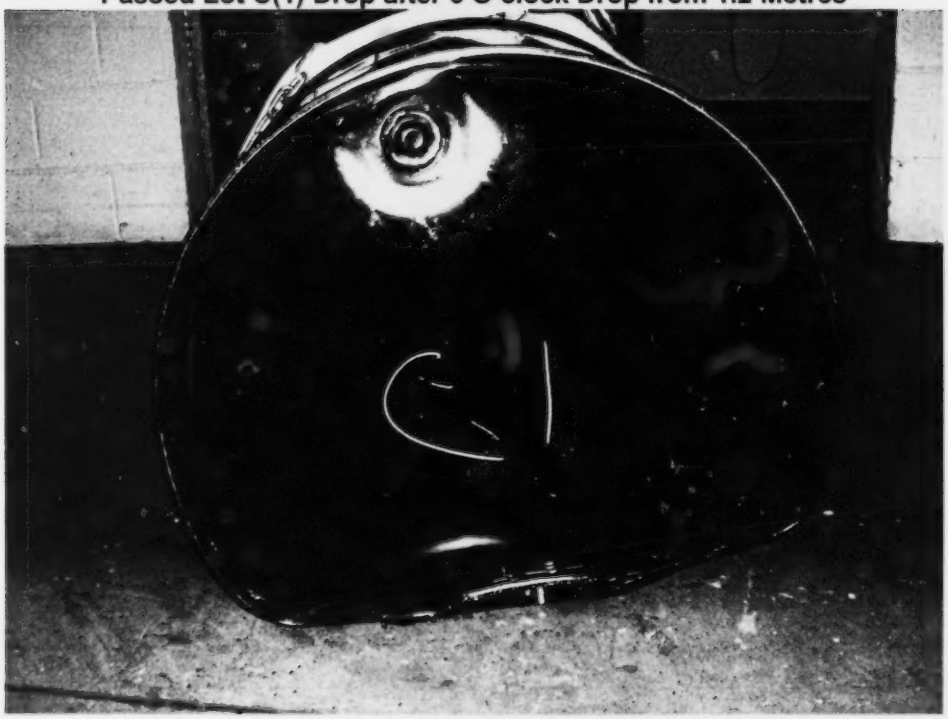
Photo 26
Passed Lot C(1) Drop after 6 O'clock Drop from 1.2 Metres

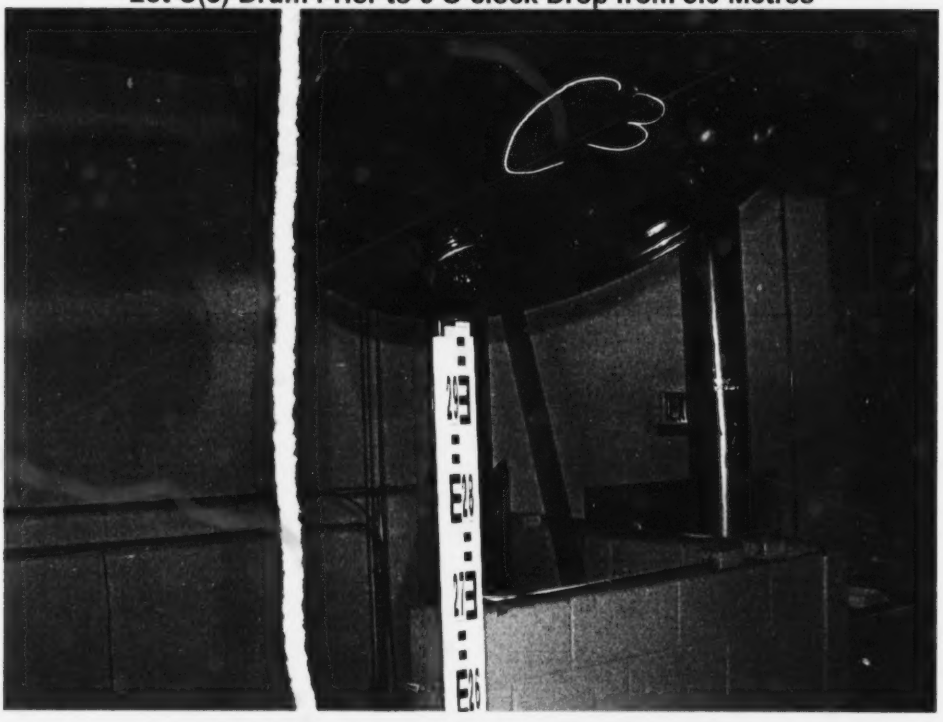
Photo 28
Failed Lot C(3) Drum - Showing Leak at Cover after 3.0 Metre Drop

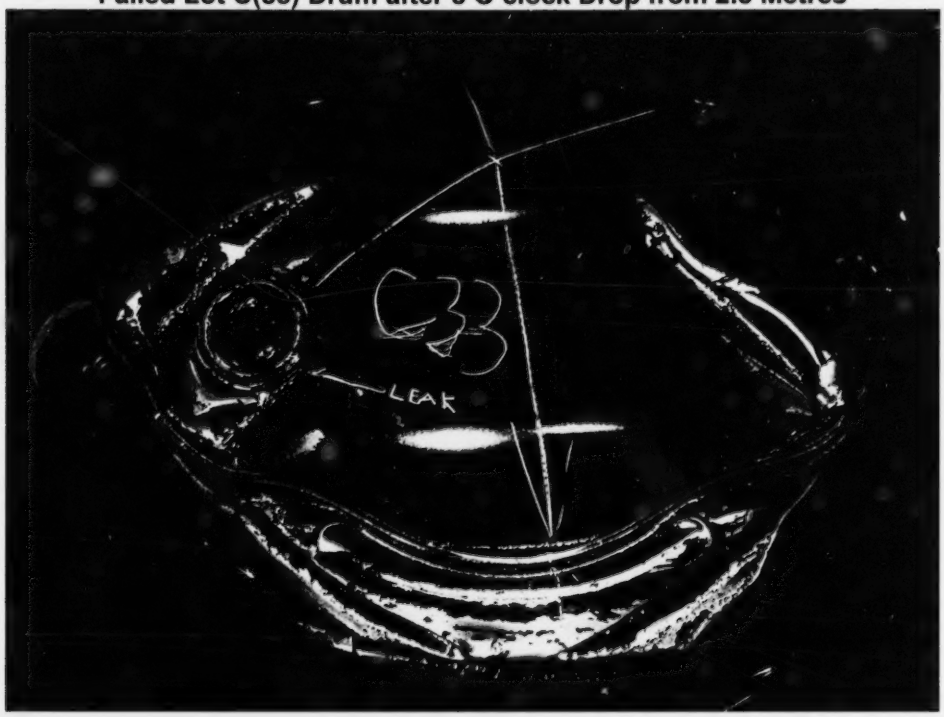
Photo 31
Failed Lot C(33) Drum after 8 O'clock Drop from 2.8 Metres

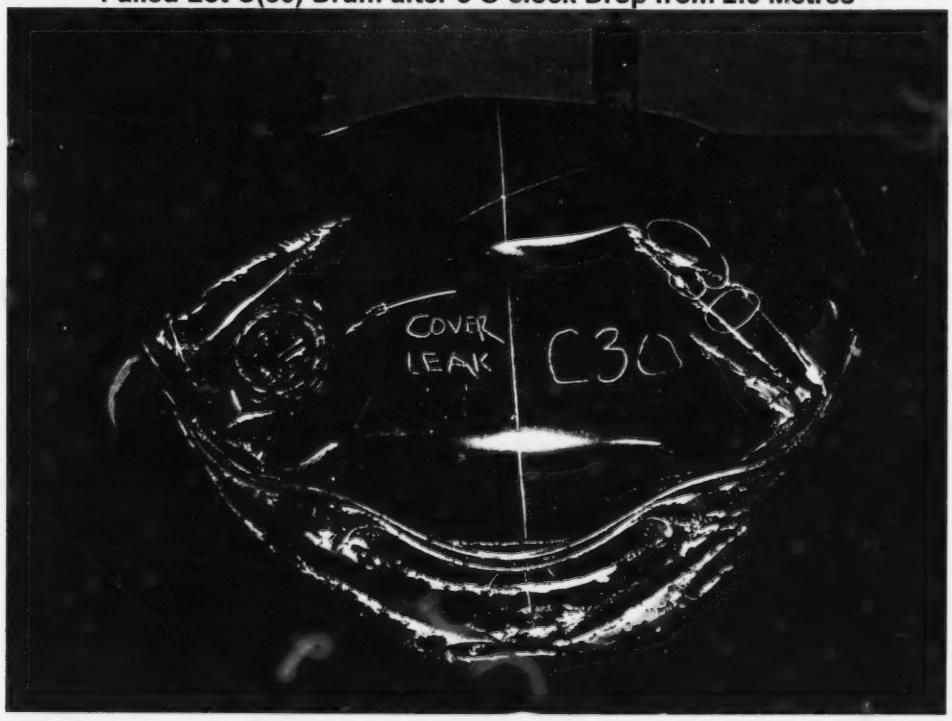
Photo 34
Failed Lot C(30) Drum after 8 O'clock Drop from 2.6 Metres

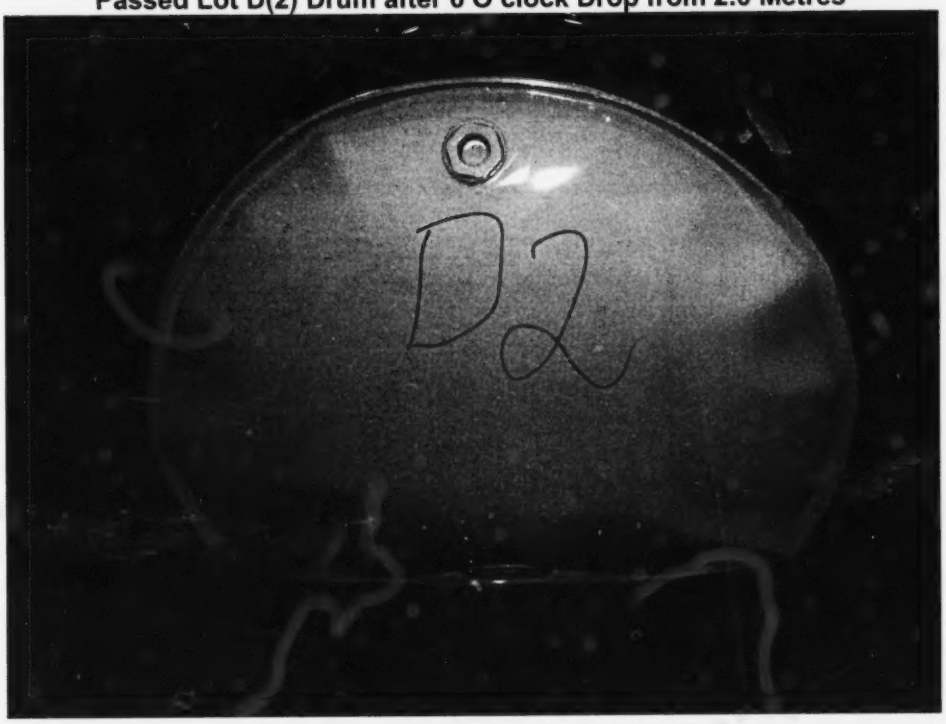
Photo 35
Passed Lot D(2) Drum after 6 O'clock Drop from 2.0 Metres

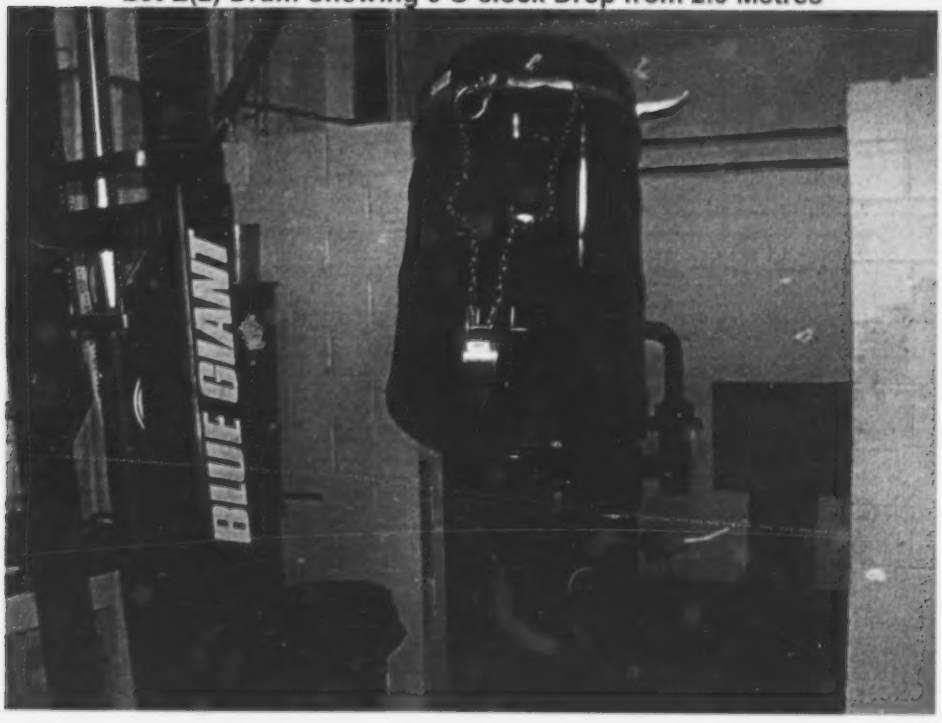
Photo 48
Lot E(2) Drum Showing 6 O'clock Drop from 2.0 Metres

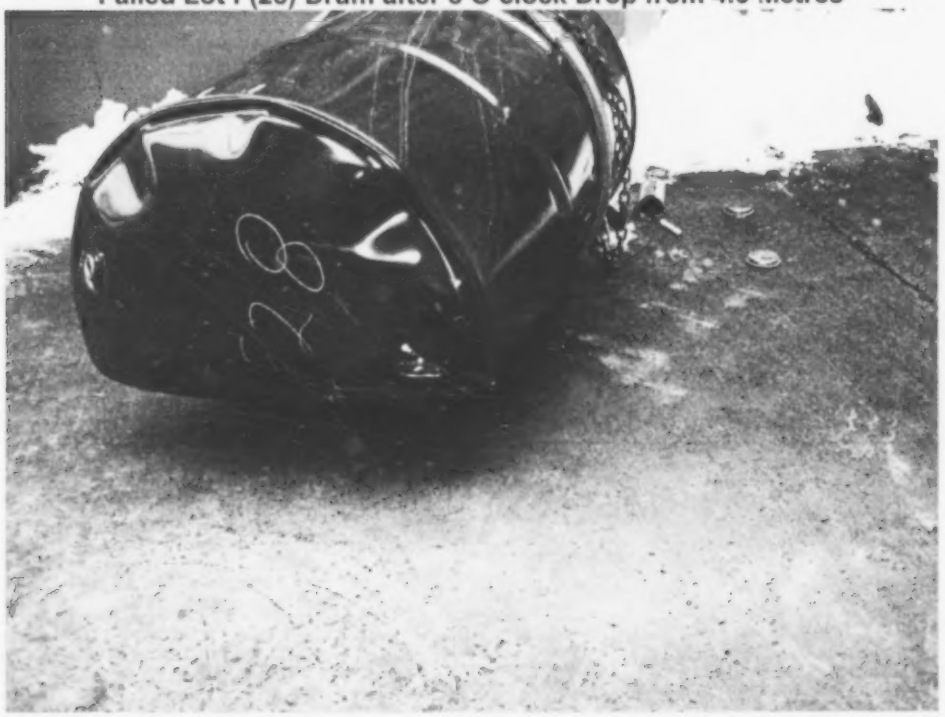
Photo 75
Failed Lot F(28) Drum after 8 O'clock Drop from 4.6 Metres
